Manhole Inspection Summary

Manhole # S33E__050MH

Insp Date: **10/27/08 10:39 AM**

Location Address: **12 n calvert st**

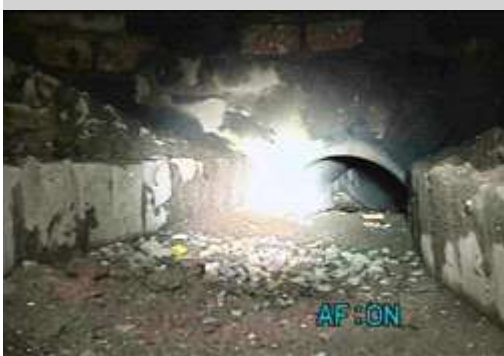
Miscellaneous

channel debris

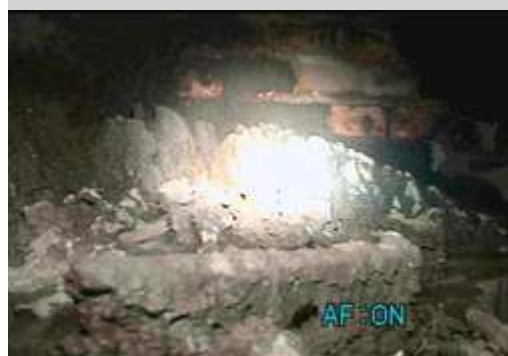
Defect 3

Condition: ☐ Sound ☐ Cracked ☐ Root Intrusion ☐ Deteriorated ☐ Leaks ☒ Debris

bench debris

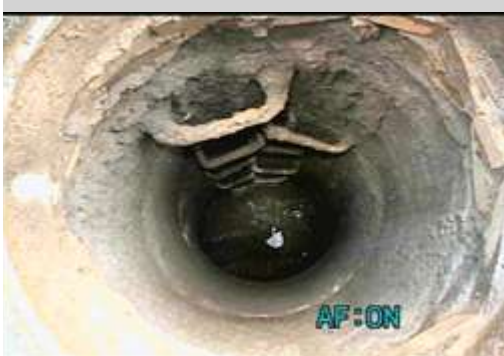
Defect 1

Steps Count: **11** Missing: **0** ☒ Corroded

corr steps

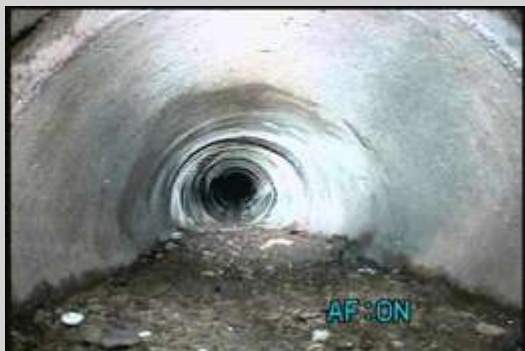
5 O'Clock Inflow

Deposits: ☐ None ☐ Mud ☒ ~~Gravy~~ ☒ Debris ☐ Grease

Silt Depth: 1.5 (in.) Deposits Extent: **Light**
